# **EXHIBIT A**

Title of Action: Kerry Rhotenberry and Robert Rhotenberry vs. Nationwide Insurance Company

- 13. Upon receipt of the initial denial of claim, Plaintiffs engaged South Wind Public Adjusters, who assigned Mario Garcia to inspect the Property and issue an inspection report. In Mr. Garcia's report, attached as Exhibit B, he thoroughly documented Hurricane Harvey-related damage to the Property in the amount of \$130,374.04, which was subsequently submitted to Nationwide/Scottsdale.

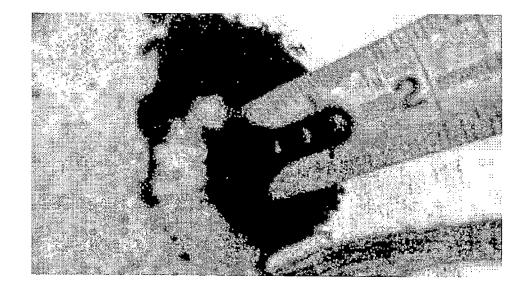
16 16-Roof

one inch deep

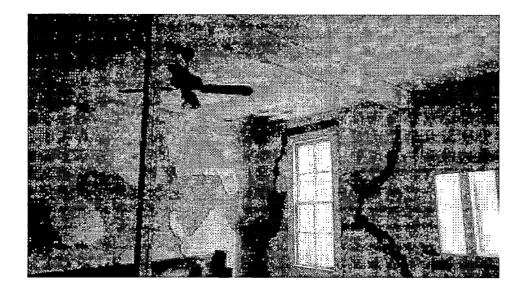
31 31-2nd story rear room Date Taken: 5/22/2018

water damage to ceiling

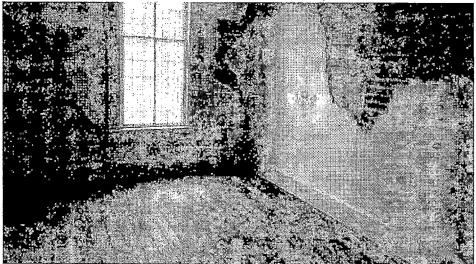
40 40-2nd story rear room Date Taken: 5/22/2018

water damage to flooring and wall
